**AMENDED
SAFETY RECALL 15E-029
STOP SALE NOTICE**

NHTSA ID: 15E029 Transaction ID: 15-001523-16441-11 (Amendment 1)

Trailer Axle Hub Stud Breakage Identification - Recall Number 15E-029

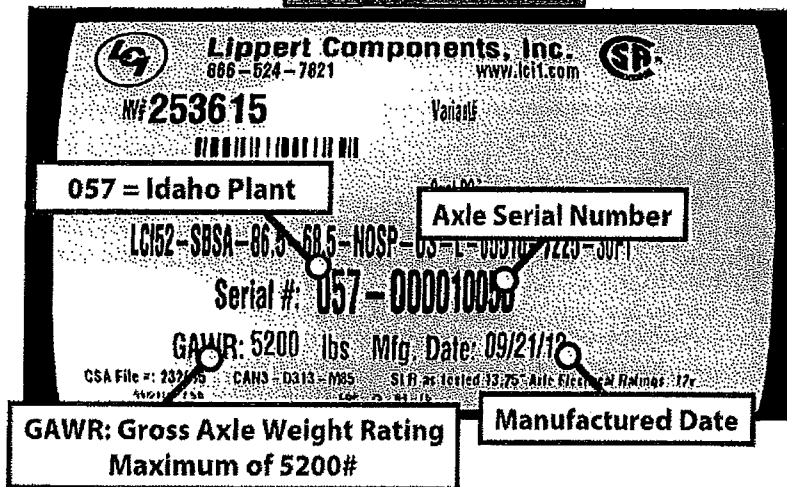
Fig. 6 - Idaho Axle Tag

NOTE: The Axle Tags demonstrate the plants from which the original axles in question were shipped, see Figs 5 & 6. Please take note of the first three numbers of the Serial Numbers on the Axle Tags to determine the plant of origin.
